# EFFECT OF CORROSION RESISTANT COATINGS ON THE FATIGUE STRENGTH OF CAST MAGNESIUM ALLOYS

James J. Bethke  
Air Vehicle Technology Department  
NAVAL AIR DEVELOPMENT CENTER  
Warminster, Pennsylvania 18974

1 SEPTEMBER 1977

FINAL REPORT  
CUSTOMER PROJ. NO. EJ-4-H0042-EJ-F6

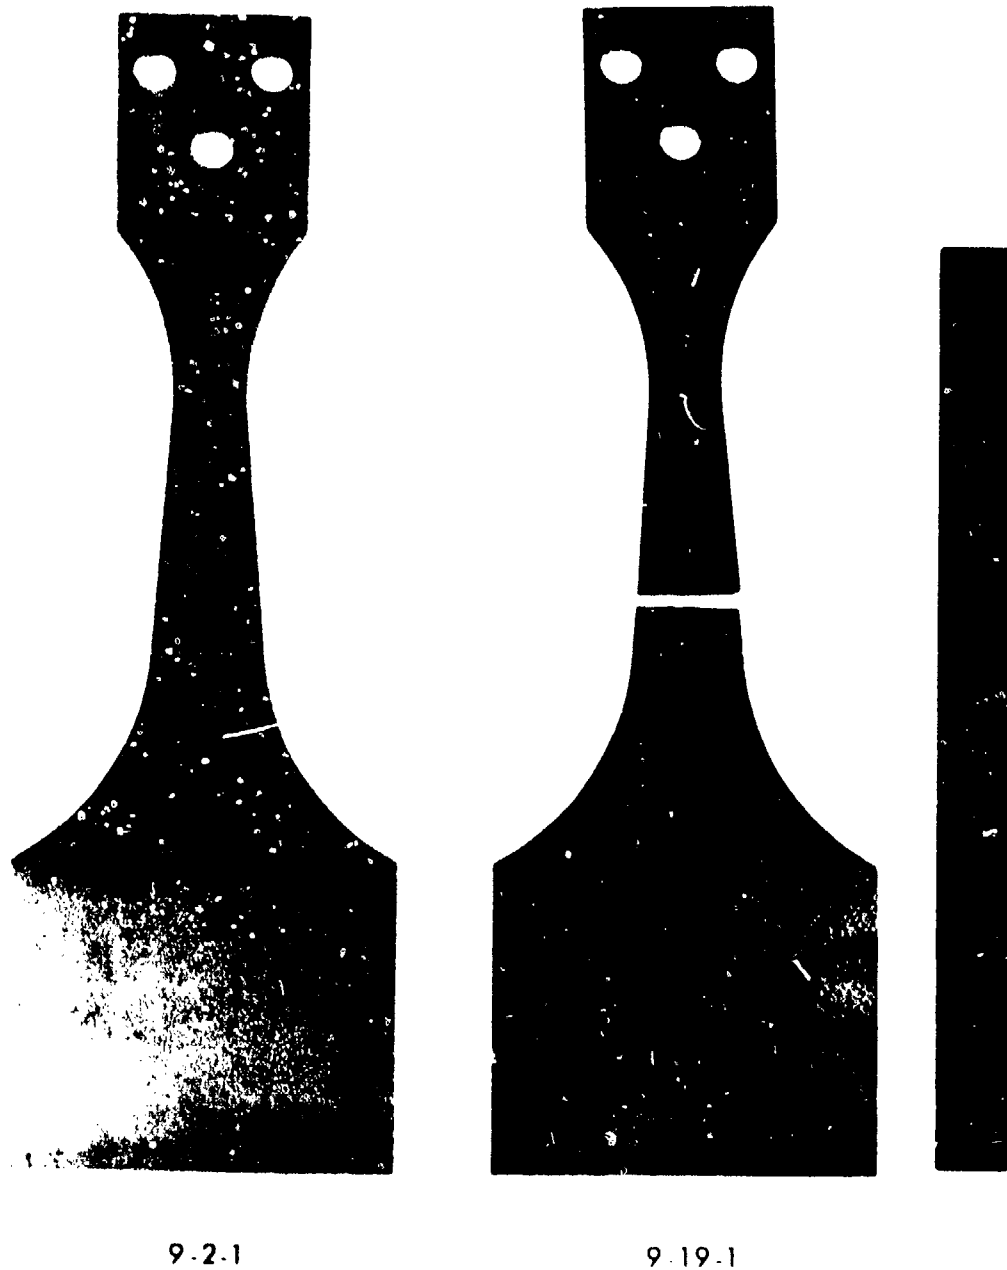
Figure 46 - Typical 1/4-In. (6.4mm) Thick Sheet Flexure Fatigue Test Specimen and Representative Failure. Specimens are AZ91 Alloy, HAF Heavy Coated (C13).

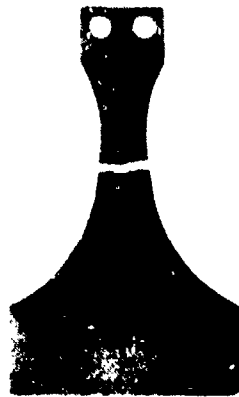
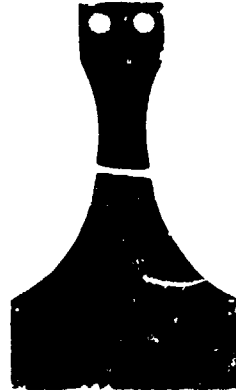
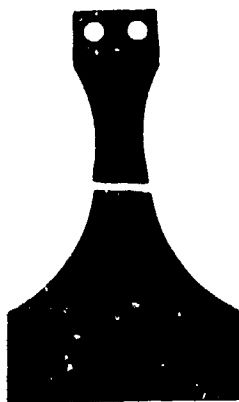
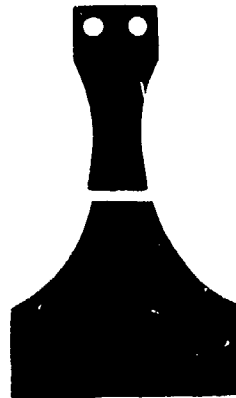
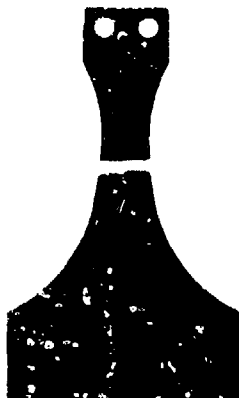
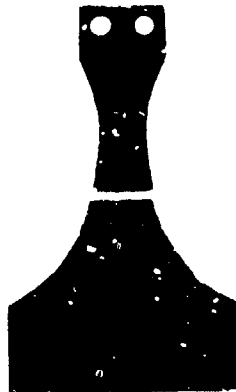
Figure 49 - Exposed (Right) and Unexposed (Left) Specimens With HAE (C11), DOW 7 (C9), and DOW 17 (C10) Coatings (Top to Bottom) Showing Very Little Surface Corrosion After 7 Days in High Humidity Environment.

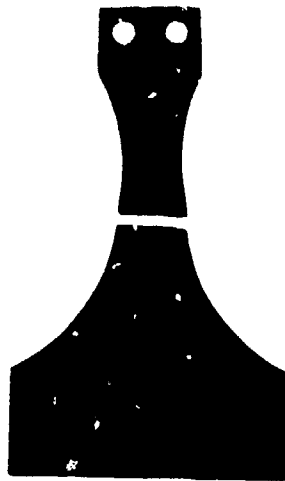
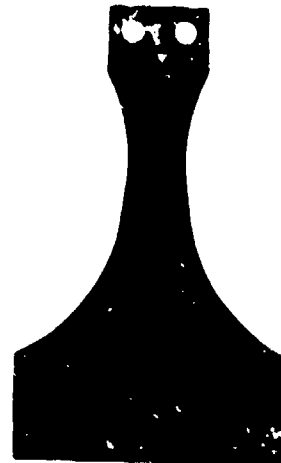
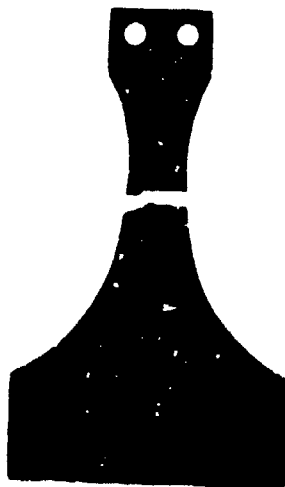
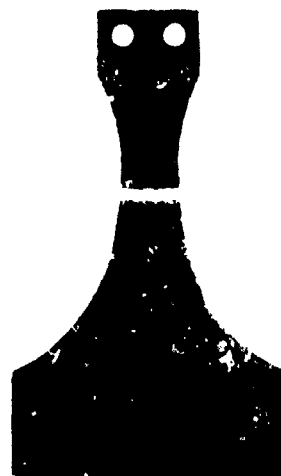
Figure 50 - Exposed and Unexposed (Upper Left Only) Specimens With DOW 7 Coating (C6) Showing Light to Heavy Range of Surface Corrosion Typical After 7 Days in 5% Salt Fog Environment.

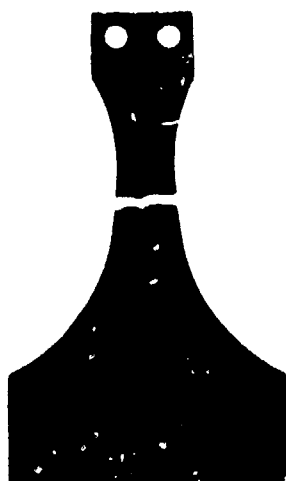
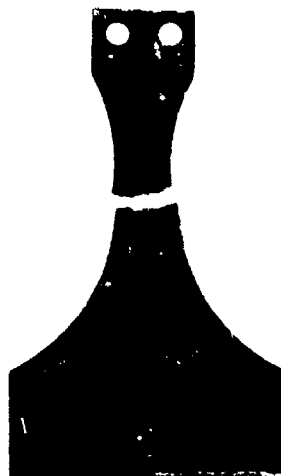
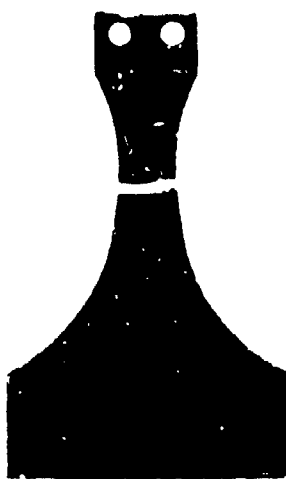
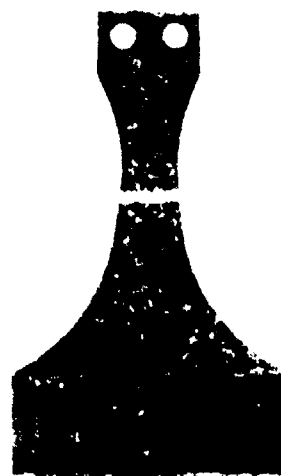
Figure 51 - Exposed and Unexposed (Upper Left Only) Specimens With DOW 17 Heavy Anodic Coating (C7) Showing Light to Heavy Range of Surface Corrosion Typical After 7 Days in 5% Salt Fog Environment.

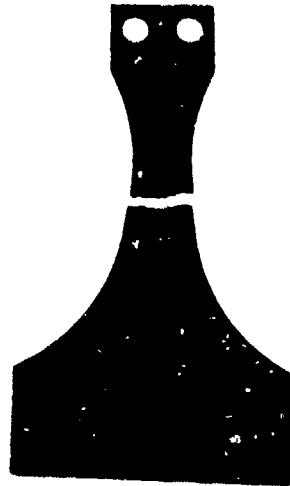
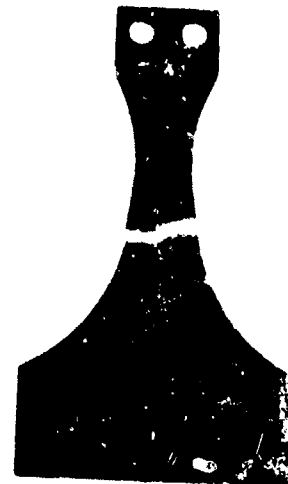
Figure 52 - Exposed and Unexposed (Upper Left Only) Specimens With HAE Heavy Anodic Coating (C8) Showing Light to Moderate Range of Surface Corrosion Typical After 7 Days in 5% Salt Fog Environment.

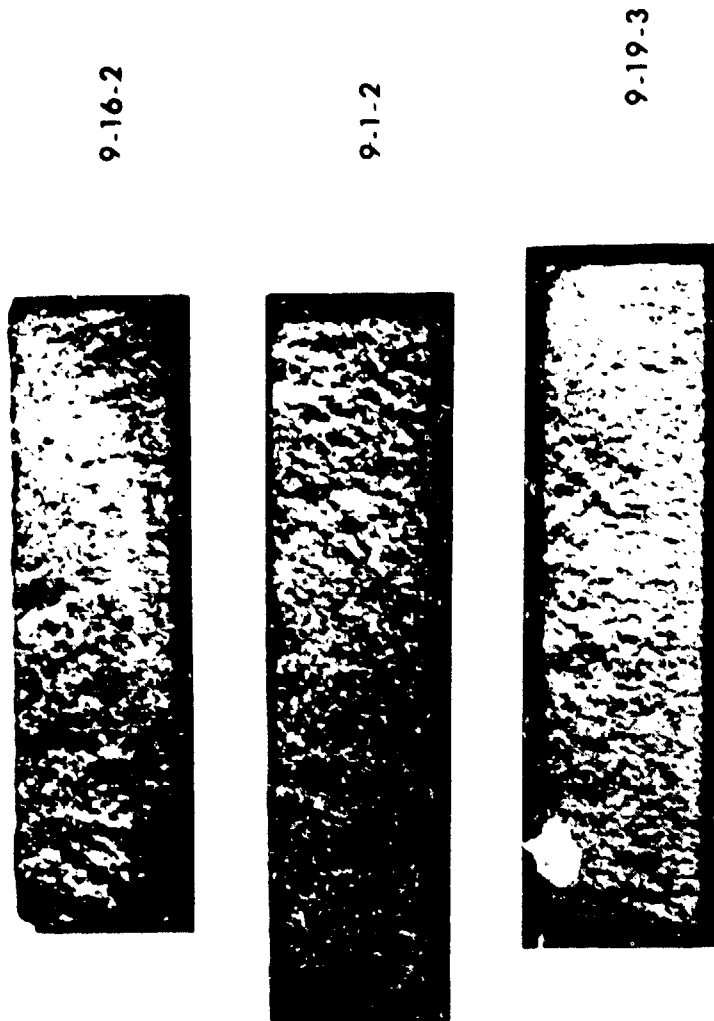
Figure 53 - Fracture Surfaces of the High Humidity Exposure Specimens of Figure 49, With HAE,  
DOW 17, and DOW 7 Coatings (Top to Bottom).

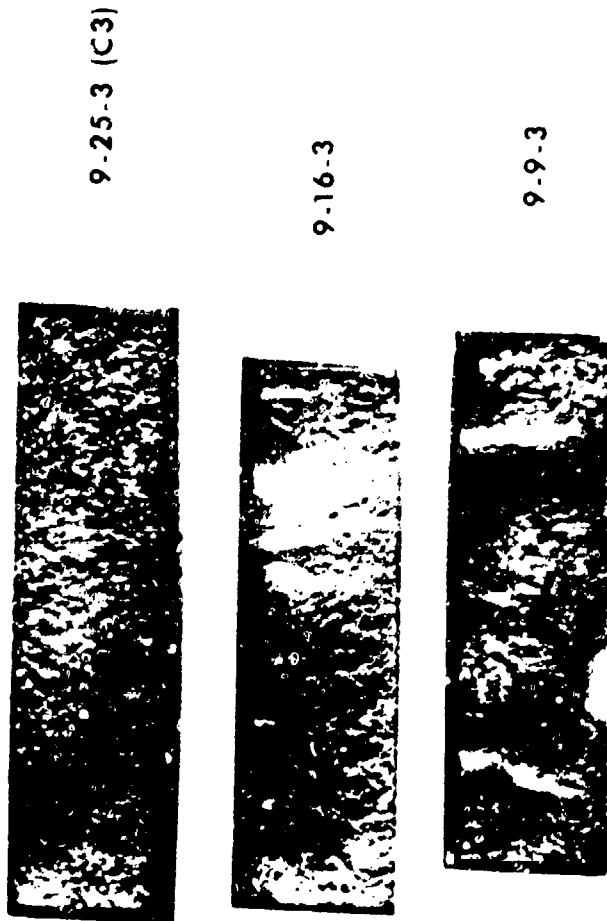
Figure 54 - Fracture Surfaces of the Salt Fog Exposure Specimens of Figure 50, With DOW 7 Coating.

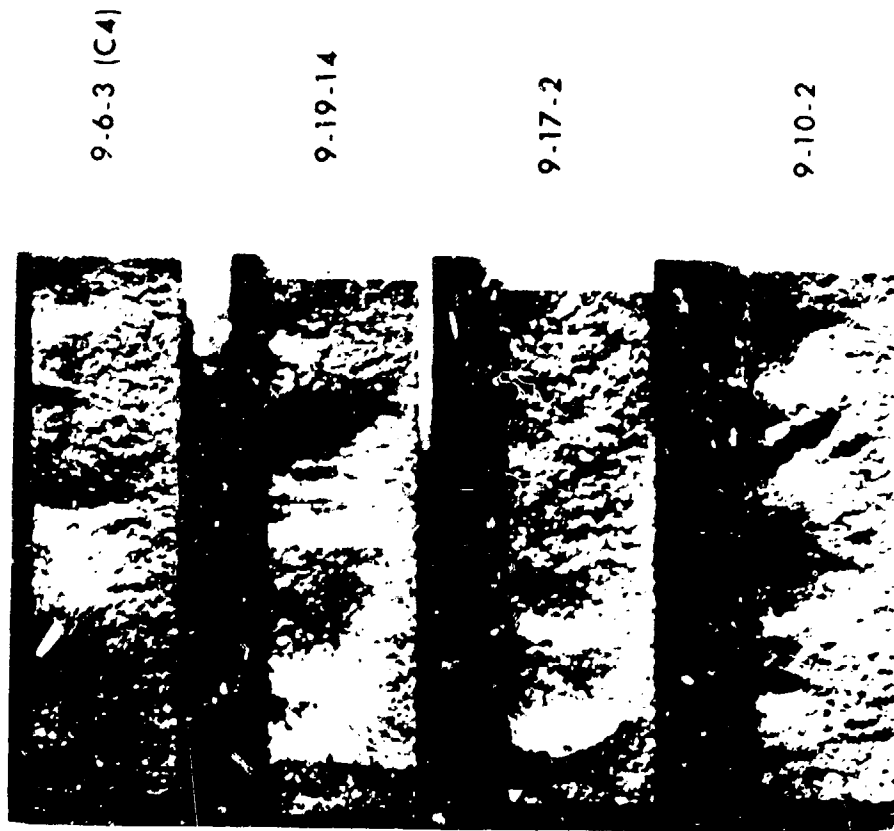
Figure 55 - Fracture Surfaces of the Salt Fog Exposure Specimens of Figure 51, With DOW 17 Coating.

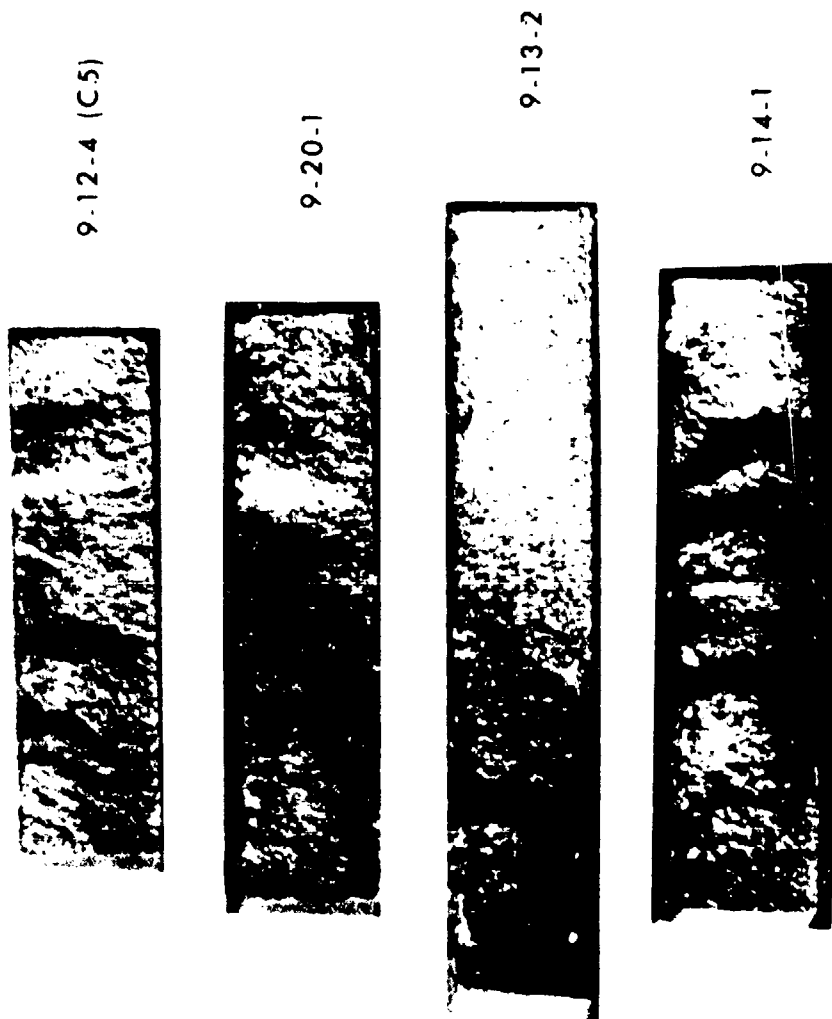
Figure 56 - Fracture Surfaces of the Salt Fog Exposure Specimens of Figure 52, With HAF Coating.
